Brazil is part of the small group of countries that accepted the challenge of implementing remediation in Antarctic soil

PHASE 1:

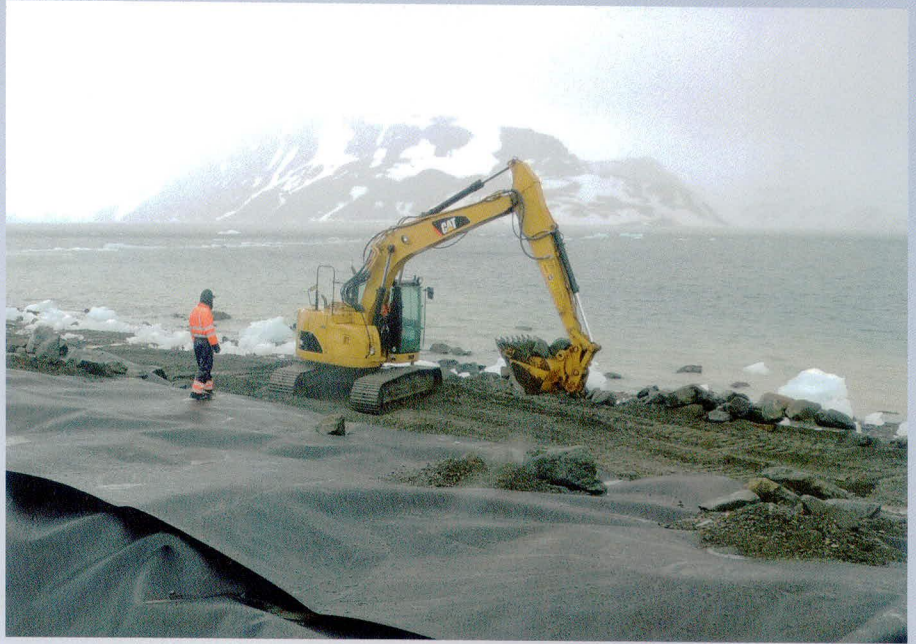
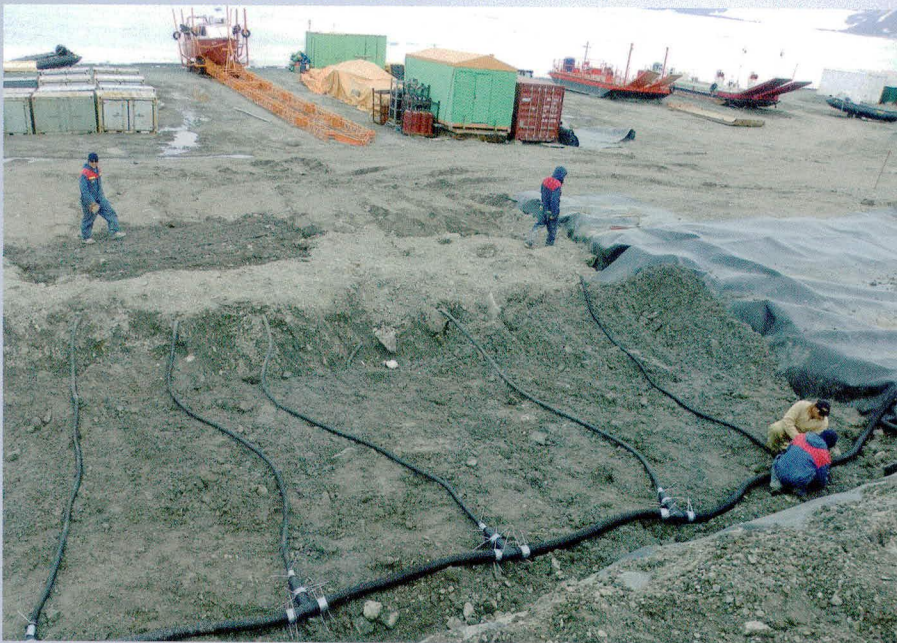
Photo: installation of Biocava's aeration network

- Due to an expected start up in the EACF's reconstruction works in the first intervention, in January 2014, the soil contaminated with hydrocarbons where there was the former engine room was treated at the location. Thus, the technique chosen for this procedure was the "biocava", which consisted of "packaging" and aerating the mixture of contaminated soil and fertilizer, using high density polyethylene membrane (HDPE) of 2 mm in thickness.

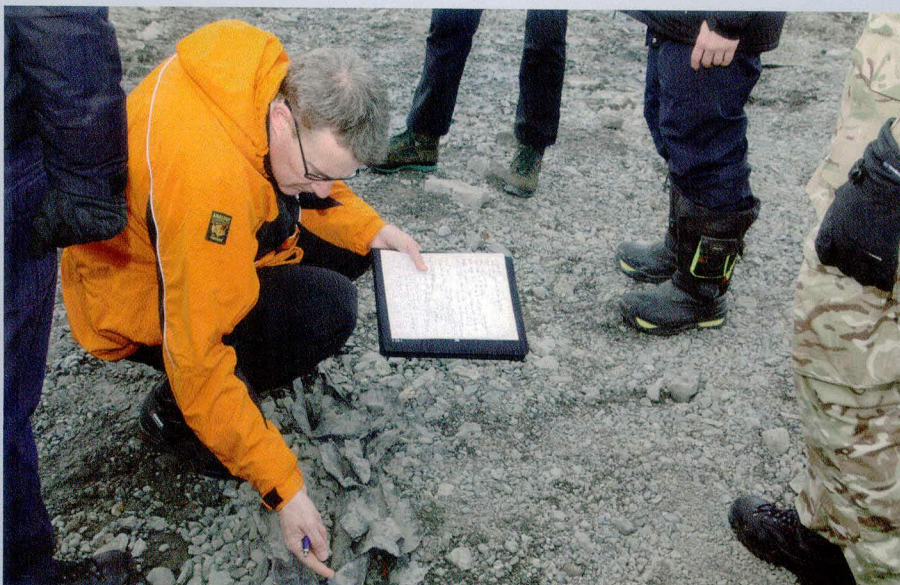
An English representative observes the process of soil bioremediation during the technical inspection Photo: Lt. Quineper

- In the second phase of remediation that took place earlier this year, the intervention occurred in the area between the treated area in the first phase and the shoreline. Conventional biopile was used where contaminated material was removed and, after being mixed with fertilizer, deposited in an area already impacted previously prepared for this purpose. The mixture will be stored in biopile until the soil is completely free of contamination or hydrocarbon levels are low.
